DEPARTMENT OF TRANSPORTATION

Contract #: 04-0120F4Cty: SF/ALA Rte: 80 PM: 13.2/13.9File #: 69.28**WELDING INSPECTION REPORT****Resident Engineer:**Siegenthaler, Peter**Address:** 333 Burma Road**City:** Oakland, CA 94607**Report No:** WIR-019846**Date Inspected:** 01-Feb-2011**Project Name:** SAS Superstructure**OSM Arrival Time:** 700**Prime Contractor:** American Bridge/Fluor Enterprises, a JV**OSM Departure Time:** 1900**Contractor:** Zhenhua Port Machinery Company, Ltd (ZPMC), Changxing Island **Location:** Shanghai, China**CWI Name:** Qiu Wen**CWI Present:** Yes No**Inspected CWI report:** Yes No N/A**Rod Oven in Use:** Yes No N/A**Electrode to specification:** Yes No N/A**Weld Procedures Followed:** Yes No N/A**Qualified Welders:** Yes No N/A**Verified Joint Fit-up:** Yes No N/A**Approved Drawings:** Yes No N/A**Approved WPS:** Yes No N/A**Delayed / Cancelled:** Yes No N/A**Bridge No:** 34-0006**Component:** OBG**Summary of Items Observed:**

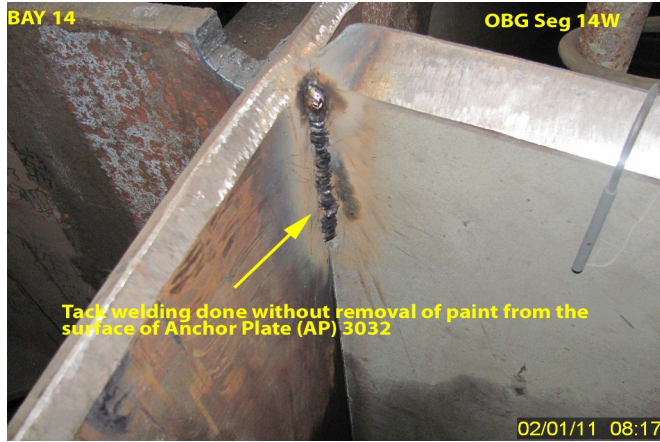
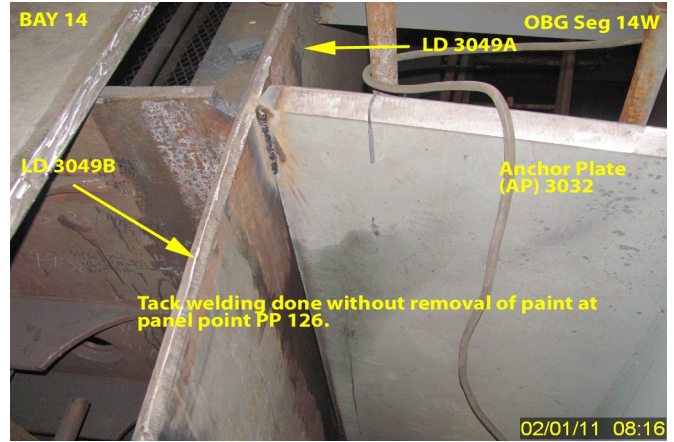
During random in process inspection this QA inspector observed that ZPMC personnel performed tack welding without removal of paint from the contact surface during fit up. The parts are identified as joining Anchor Plate (AP) 3032 to Longitudinal Diaphragm (LD) 3049A at Panel Point (PP) 126. The welder is identified as 066481. This issue has been discussed with AB/F QA Mr. Kim and CT lead QA. Mr. Kim informed this QA that this issue would be solved in manner compliant with contract documents. Later on this QA observed that ZPMC removed those tack welds, ground out weld and remove the paint properly and installed the part again. Attached photograph provide additional detail.
